TECHNICAL NOTE 3269

ADDITIONAL STATIC AND FATIGUE TESTS OF HIGH-STRENGTH
ALUMINUM-ALLOY BOLTED JOINTS

By E. C. Hartmann, Marshall Holt, and I. D. Eaton

Aluminum Company of America

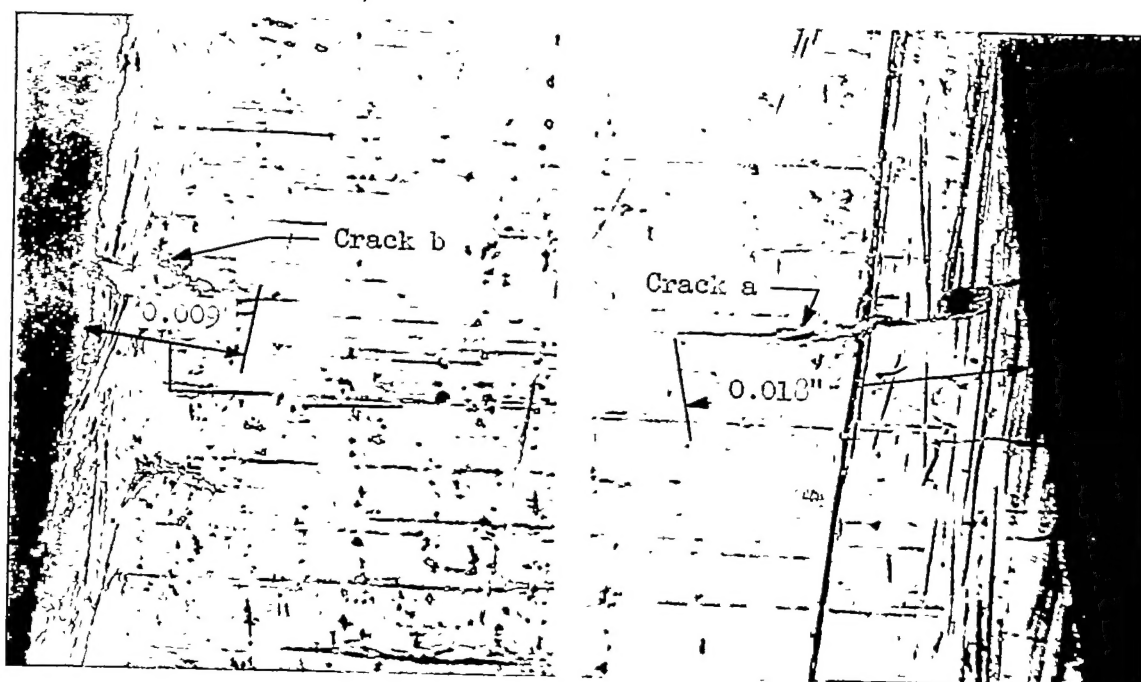
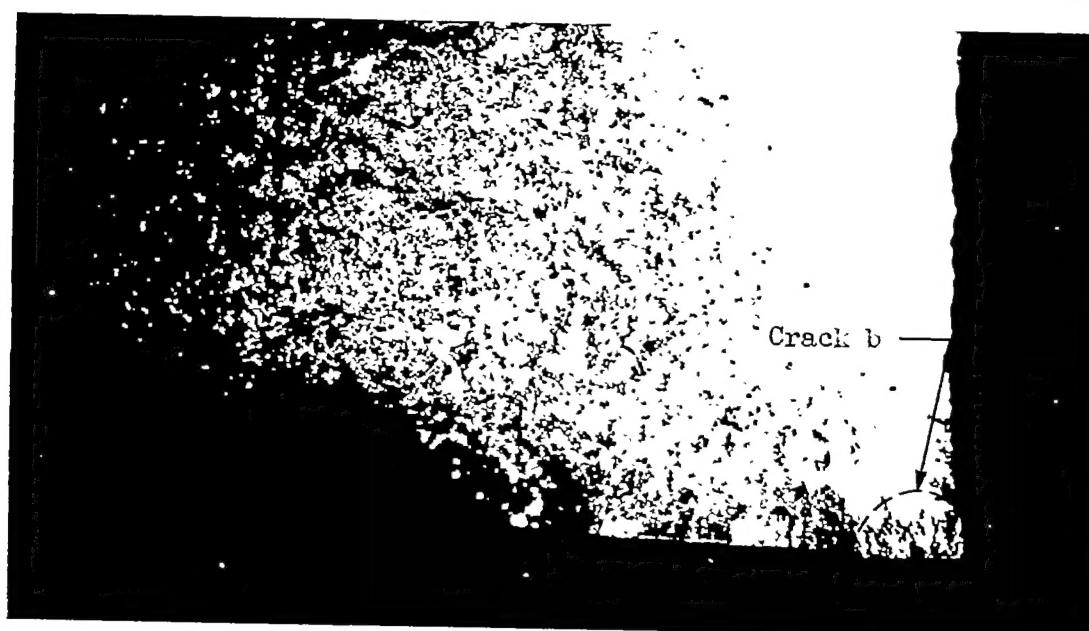
Figure 18.- Enlargements of additional failures in 24S-T4 nonuniform-step joint. (For locations, see fig. 17.) Two photographs at top are of Faxfilm replicas.

When the bolts were removed individually from the reassembled joints, it was found exceedingly difficult to obtain evidence of the existence of some of the cracks by means of the penetrant inspection methods used. In the case of the smallest crack no evidence of its existence was found. Further, no indication was obtained of the existence of the crack, about 0.009 inch long, shown in figures 17 and 18 when the methods were used with this joint in the disassembled condition.

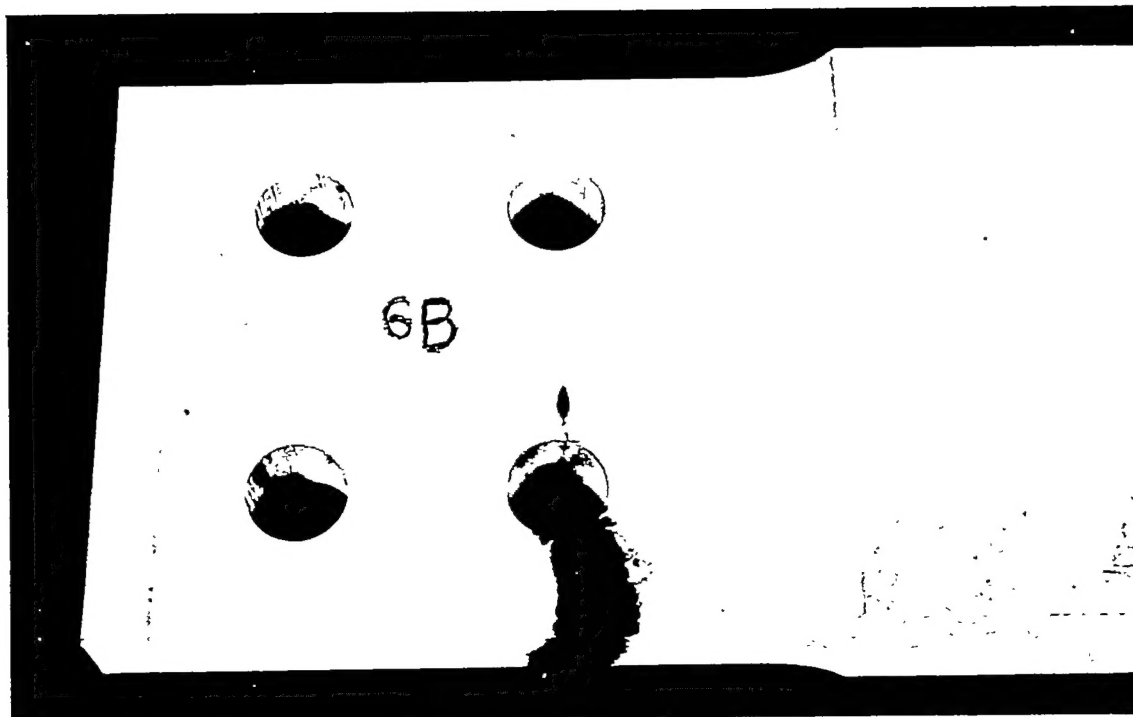
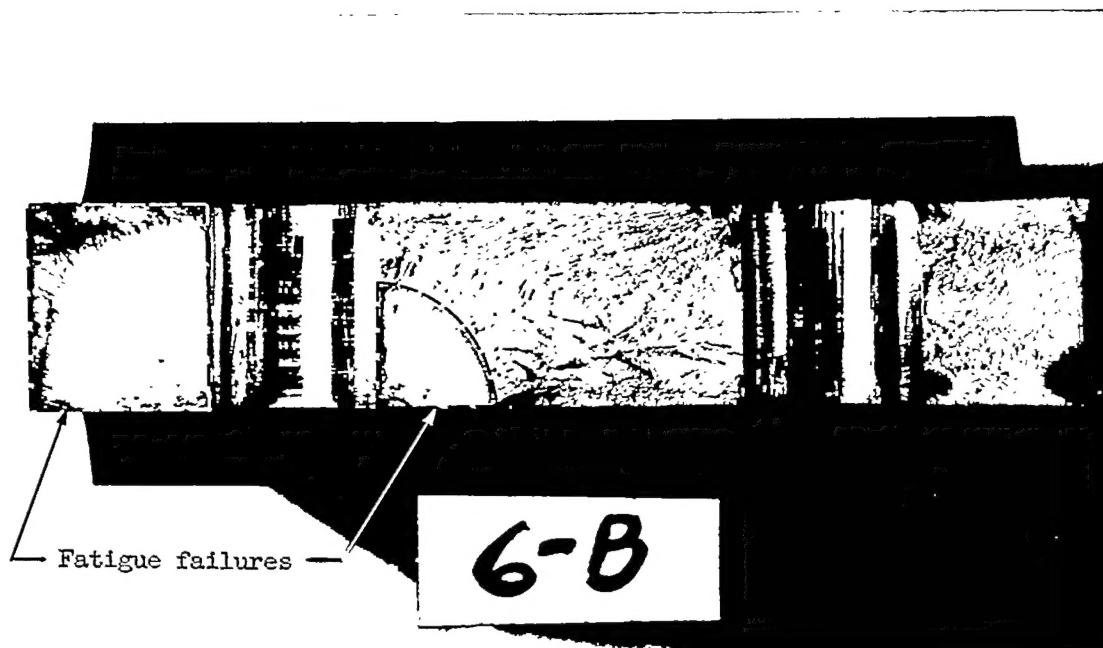
Figure 19.- Failures in 75S-T6 double-shear joint.

The static loads required to fail the 75S-T6 and 24S-T4 double-shear joints after the fatigue cracks shown in figures 19 and 20 had been developed are given in table VII. Included in the table are comparisons with the expected load based on the net area obtained by correcting for the cracks and the load-carrying capacity of a similar joint not having previous cyclic-stress history. Outlined on the fractured surfaces in figures 19 and 20 are the areas involved in reducing the net area for estimating the effective load-carrying section of the specimens. It can be seen that one section of the 75S-T6 joint between the bolt hole and the outside edge was completely fractured by the fatigue loading whereas the 24S-T4 joint did not completely fracture in this area. Before subjecting the 24S-T4 joint to the static loading, however, a saw cut was made into the bolt hole from the outside edge in order to produce more nearly identical conditions in the two specimens. The location of the cut is shown in figure 20. Thus for purposes of the comparison this section of the joint has been considered as though it had been completely fractured in fatigue. Further, the additional failure in the centrally located portion of the joint adjacent to the bolt hole in the 75S-T6 joint caused a substantially larger reduction in the section than was the case in the 24S-T4 joint. Thus the cracked 75S-T6 joint would be expected to be subjected to a larger eccentricity of loading than the cracked 24S-T4 joint.

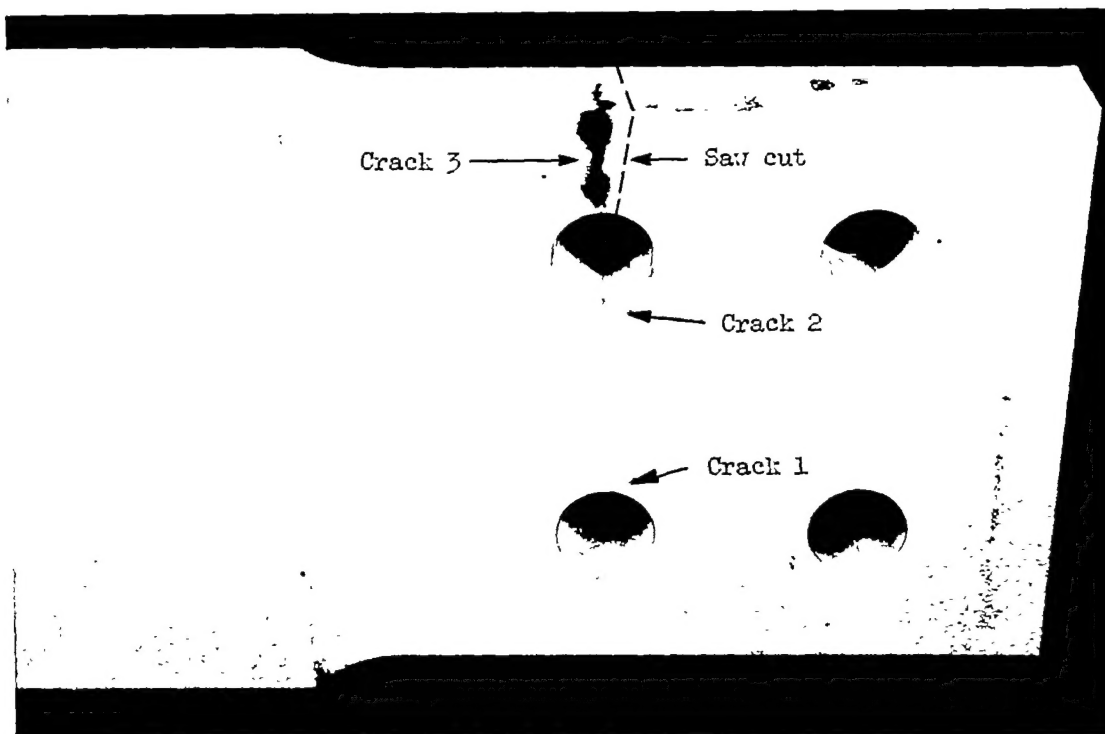
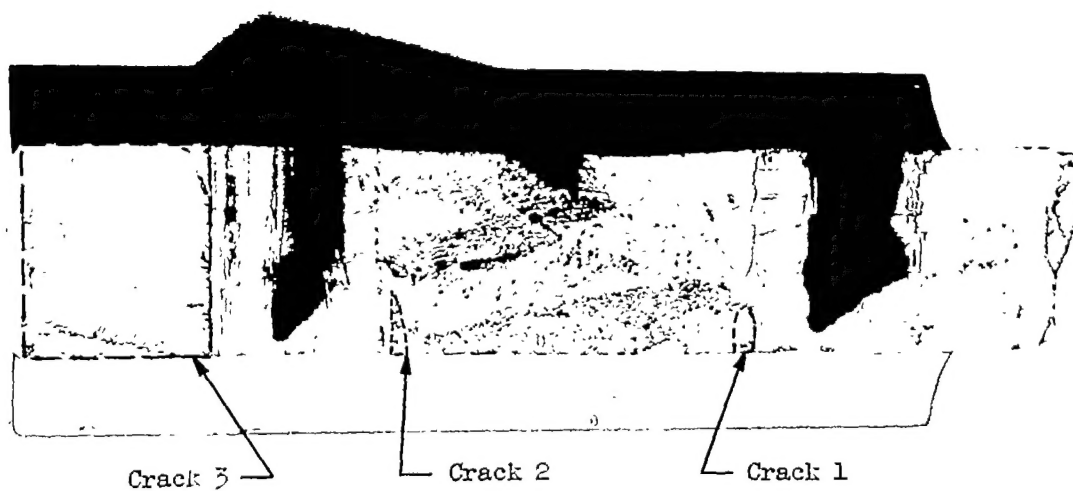
Figure 20.- Failures in 24S-T4 double-shear joint. Specimen 6D. (For enlargement of small cracks see fig. 21.)

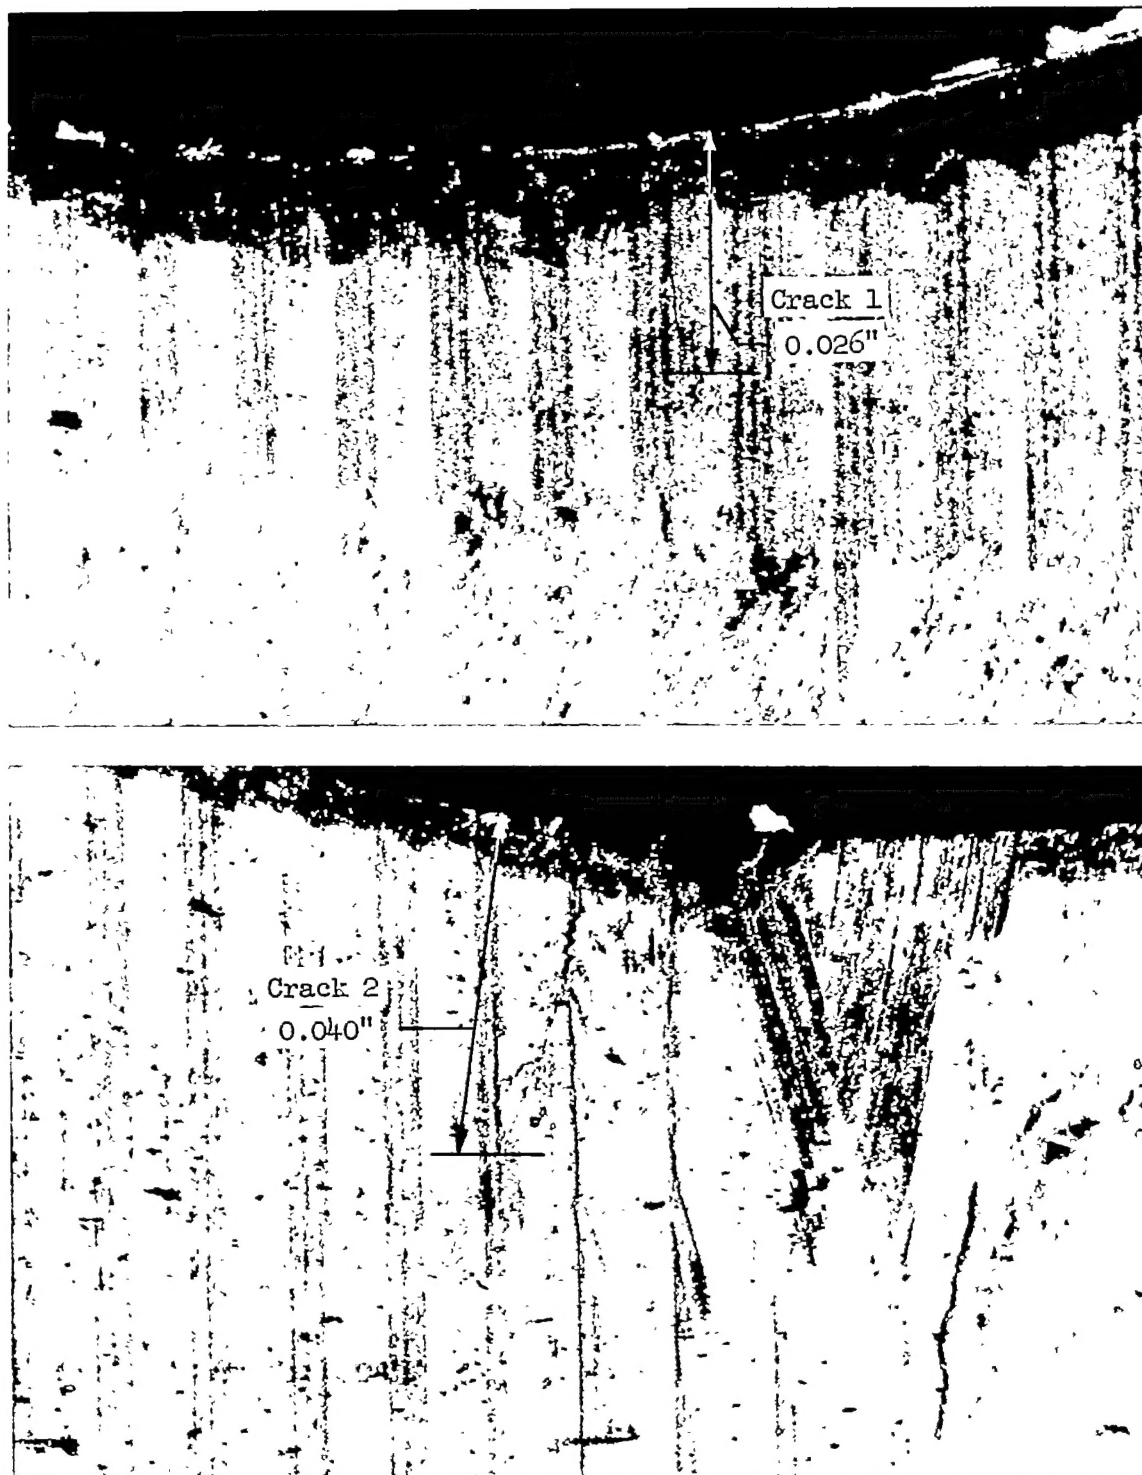
L-83701
Figure 21.- Enlargement of failures in double-shear joint. 50X. (For location see fig. 20.)
